Problems occurring due to oil lines on circular knitted fabrics

by Mukesh Gupta.

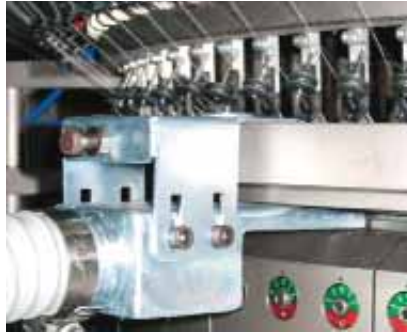
Suction nozzle placed on the dry zone of the needle to extract oil and lint.

Cleantech has developed an oil and lint extraction system, which consists of two purpose designed oil and lint extracting suction nozzles, which are placed on the dry zone of the needle, just above the cam boxes on the rotating cylinder. The rotating cylinder ensures that each needle is subjected to suction by a nozzle, two times in each revolution of the cylinder. High volume suction air flow is provided by a purpose designed low power vacuum generator based on maintenance and oil free side channel regenerative blower.

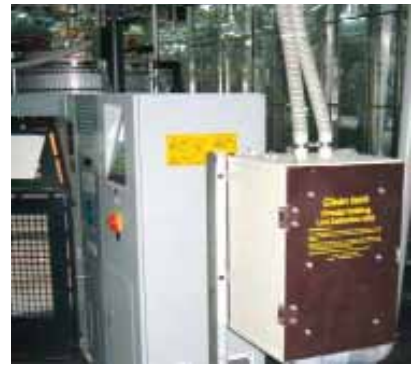
Extractors installed for a Mayer & Cie single jersey knitting machine.

Any oil or lint trapped in the dry zone of the needles is sucked out and removed to the waste and oil collector in the extraction system. The filters in the extraction system are

designed to separate the lint and oil. Lint is trapped in the filters and the oil is collected and discharged to an external container. The extraction nozzles are designed to act only on the exposed dry zone of the needle and not to extract any lubricating oil from the needle tricks or cam boxes of the knitting machine.
